## uPVC Profile Extrusion

### 957 Ionising Air Curtain

## APPLICATION NOTE

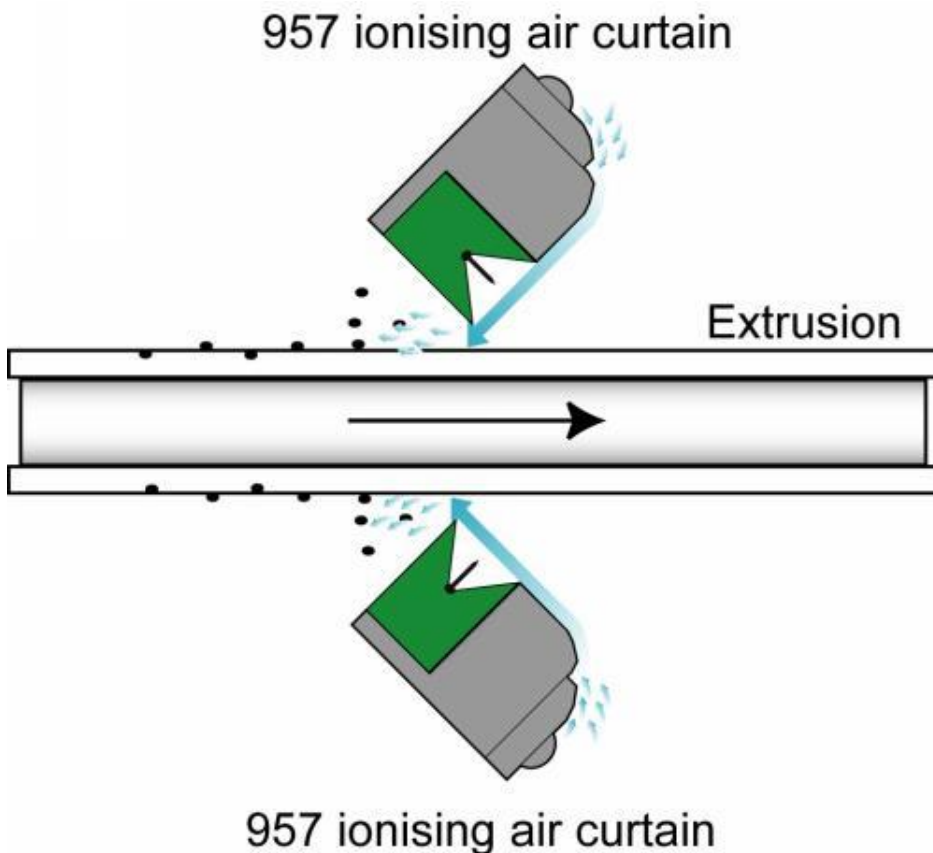
Fig.

Carefully positioned 957 ionising air curtains can both release and neutralise swarf and also neutralise the profile assuring a clean and static free section at the end of the extrusion line. A barrier can also be created at the saw box extraction system, enhancing its performance and preventing contamination of the outer working area.
