Bottle Labelling

915 Ionising Bars

APPLICATION NOTE

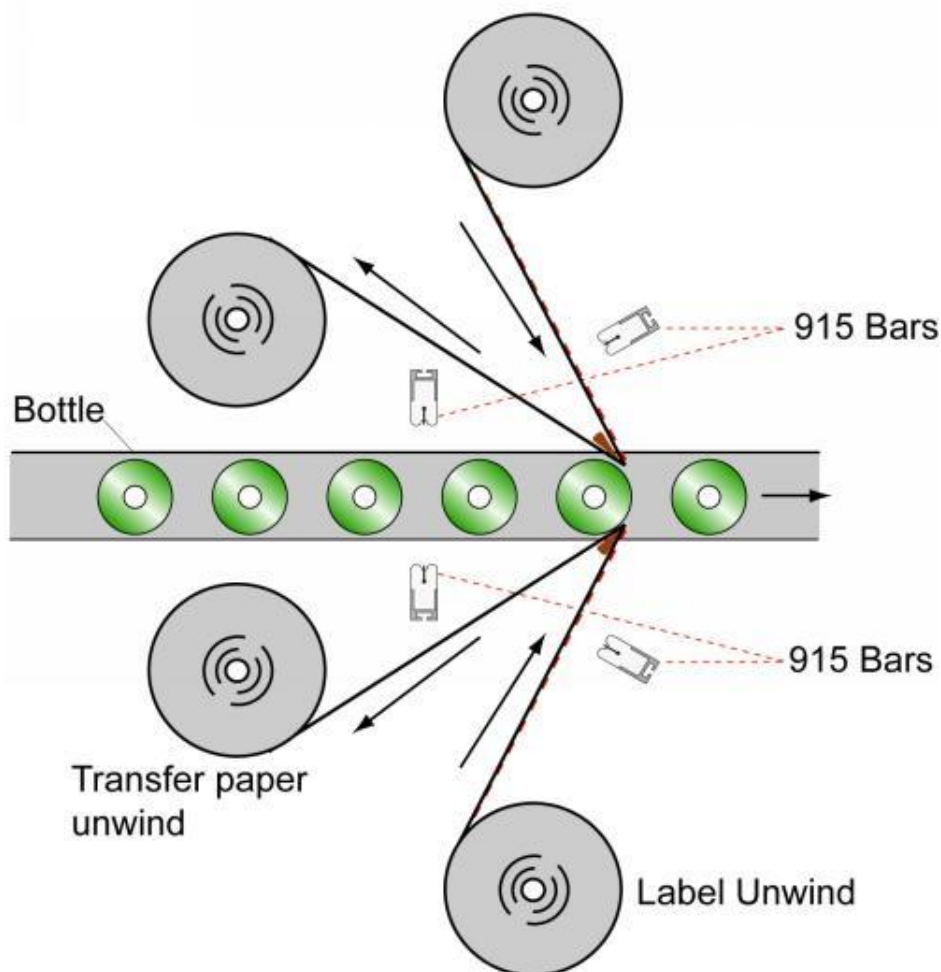
Top View

Model 915 ionising bars positioned as shown above will neutralise static charges on the label web and the plastic bottles. This solution will allow correct labelling and improve process productivity.

The build up of static electricity on the label web or on the plastic bottles will result in poor label feeding or incorrect label placement and positioning. These problems can result in the mislabelling of bottles, slower production speeds and a higher defect rate.
