Cooling Blow Mouldings

Meech Air-Tec Air Curtains

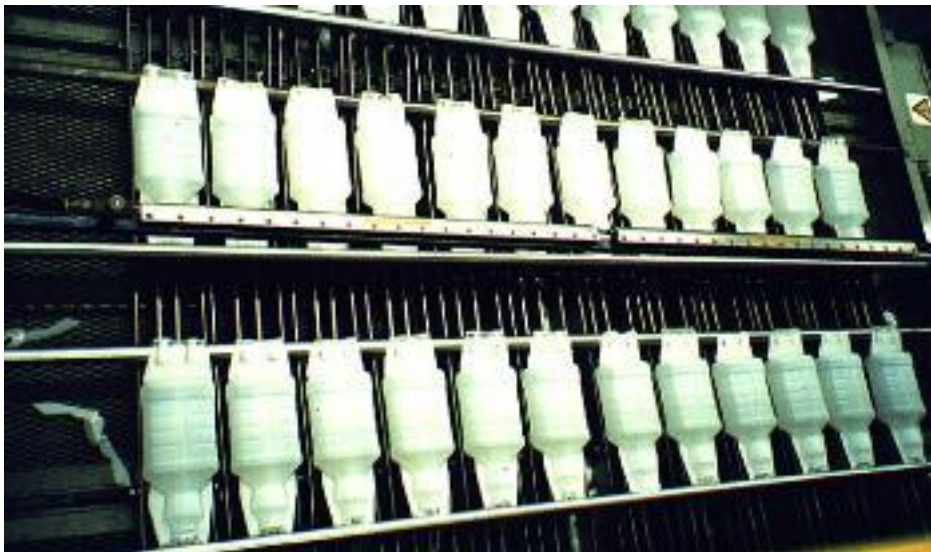
Fig.

A plastic container manufacturer was suffering major problems when removing the flashing from the leading and trailing edges of recently moulded containers. The containers are on a step conveyor approaching a guillotine (as pictured) where the flashing is to be removed. The problem occurs because of the heat retained in the containers from the previous moulding process. As the guillotine slices across the flashing it causes the container walls to collapse resulting in three problems: • High Reject Rates • Loss of Profit • High Customer Dissatisfaction

Meech Air-Tec Air Curtains deliver a high volume of compressed and ambient air operating at 80psi (5.5 Bar). The Meech Air-Tec Air Curtain entrains a large amount of ambient air which is sufficient to cool the containers. This has allowed the clean removal of the flashing whilst preventing the possibility of the container walls collapsing. A Meech Air-Tec Air Curtain has the potential to give a 25:1 air amplification.
